The World's Strongest Catana 401

August 28, 2009

Kaya, a Catana 401, arrived here in early June for major structural repairs.

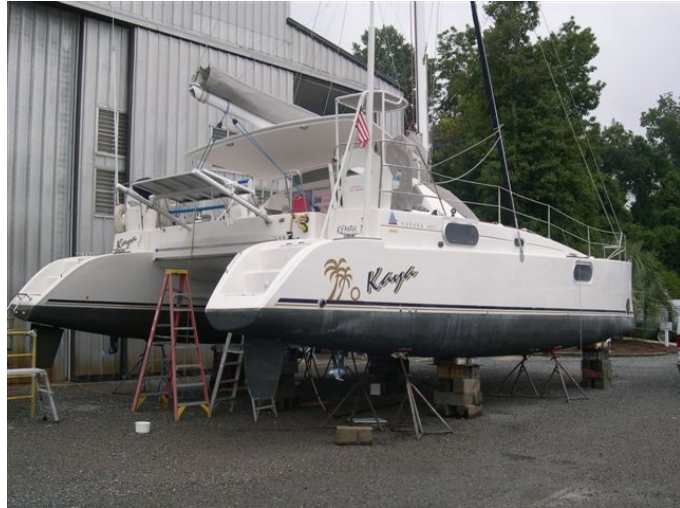
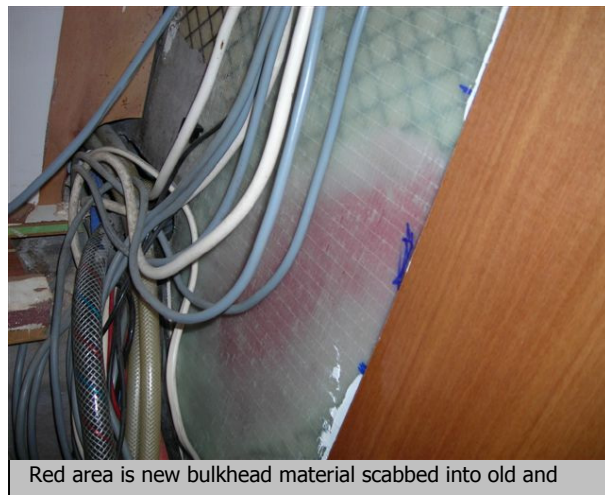
Because of the new thickness, our carpentry department is crafting new teak bulkhead caps – the trim around openings to the berths, passages, and doors.

We are strengthening the vessel by laminating another layer of Divinycell to each side of the majority of the bulkheads. The newly formed surface is then glassed over and tabbed to the hull - creating bulkheads that are essentially double the original thickness.

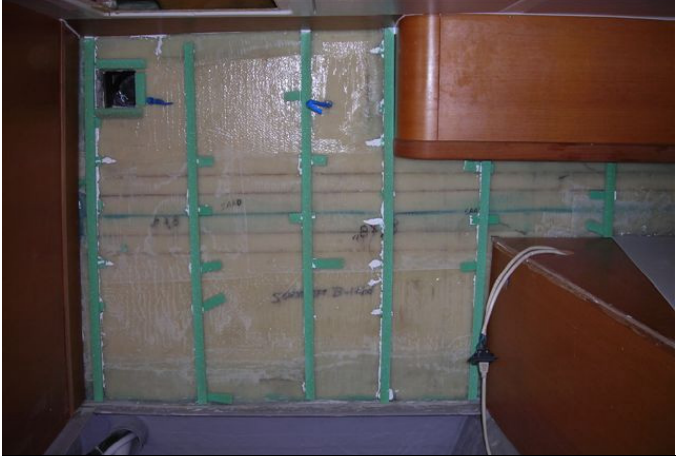
Newly reinforced aft cabin bulkheads ready for paneling.

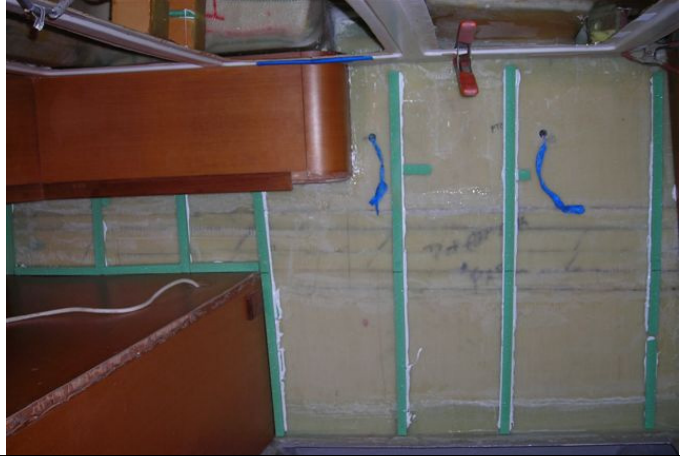
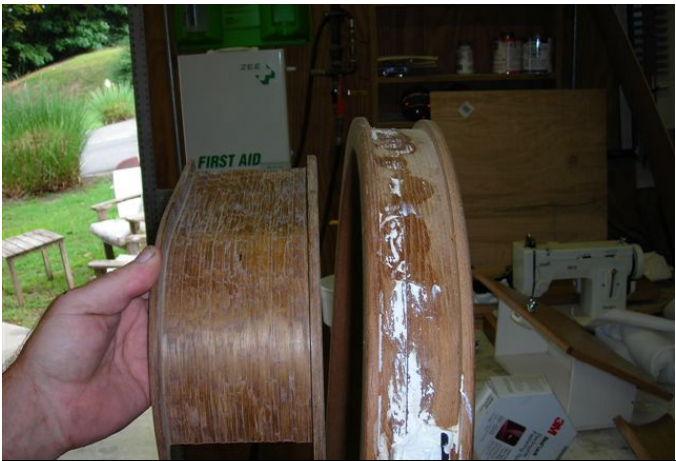
Thickness difference between new and old bulkheads.

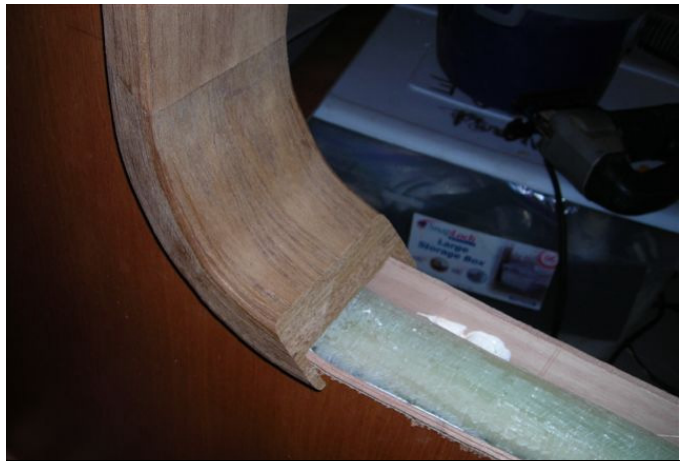
New bulkhead with trim temporarily fitted.

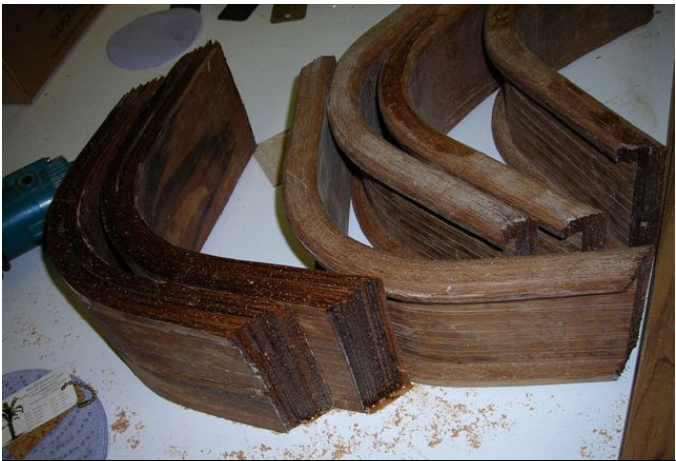
Custom-laminated corner trim in various stages of completeness.

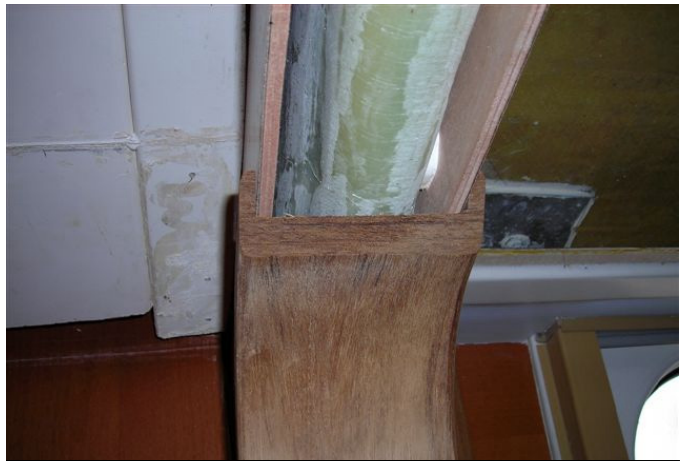
New bulkhead with trim temporarily fitted.

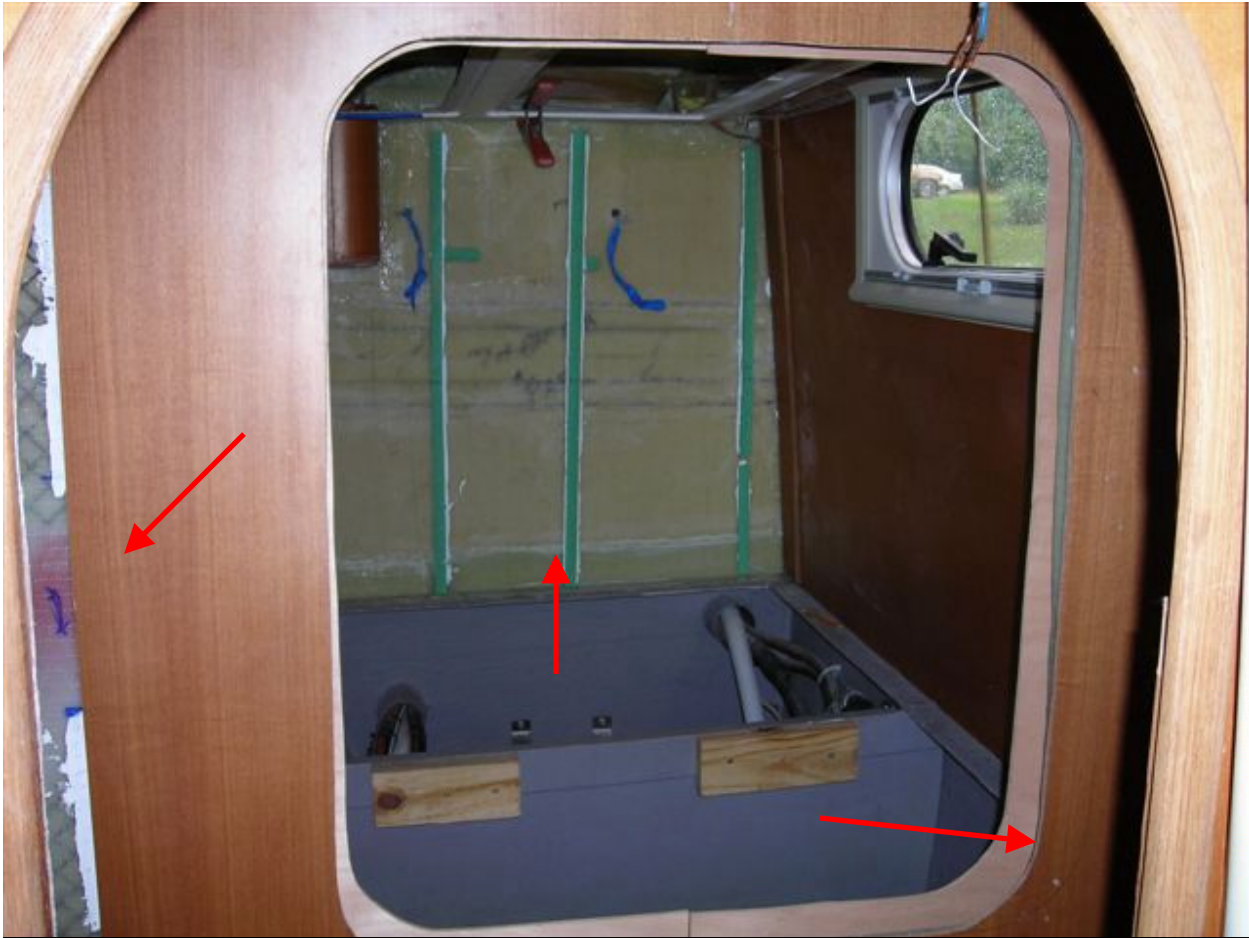
New or strengthened bulkheads indicated by arrows.

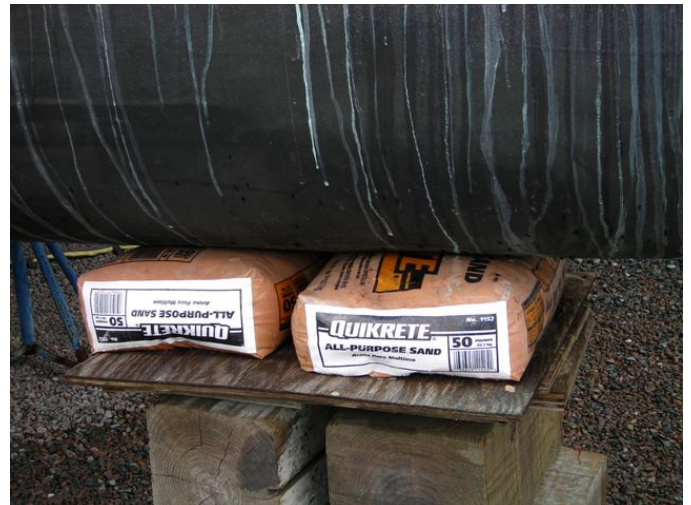
Sandbags required to prevent hull damage.
